SOUTH FORK CLEARWATER RIVER **HABITAT** ENHANCEMENT
CROOKED AND RED **RIVERS**

ANNUAL REPORT - 1989

U. S. **Forest** Service
Nez **Perce** National **Forest**

Contract Number **DE-AI79-84BP16475**
Project Number 84-5

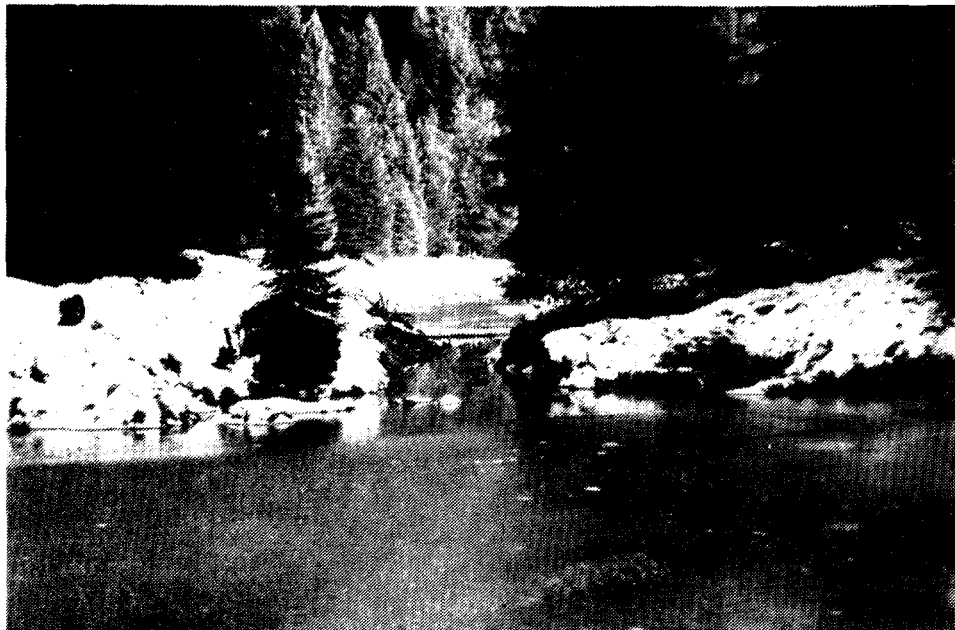
Figure 3 - Inlet Channel to Pond

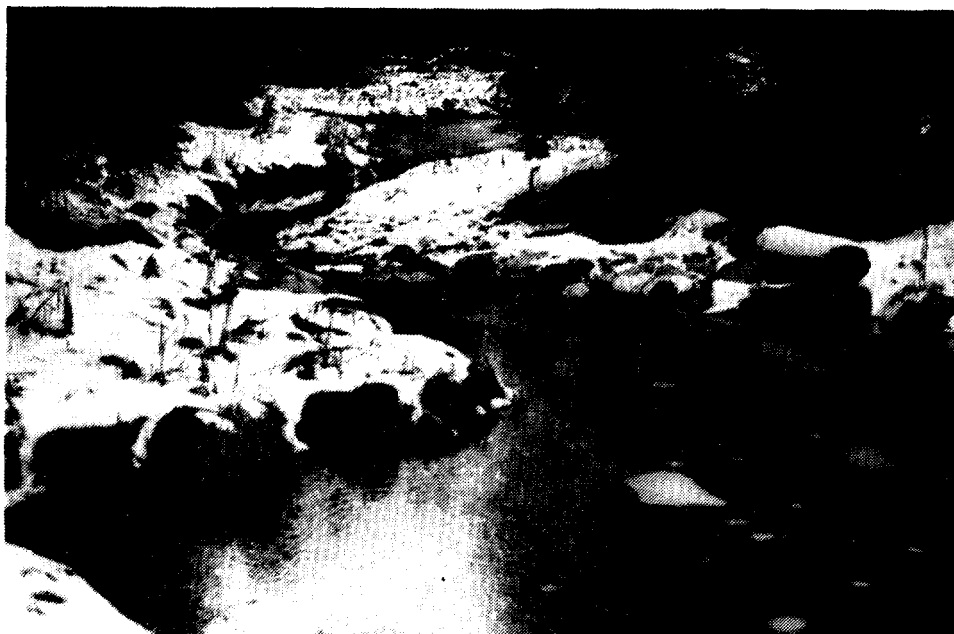
Figure 4- Connecting Channel between 2 Ponds

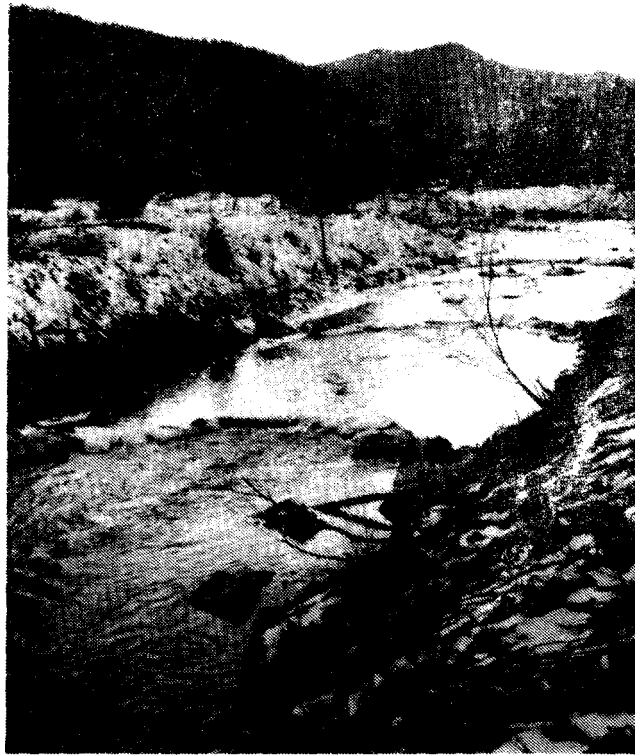
Figure 5 - Upstream V's

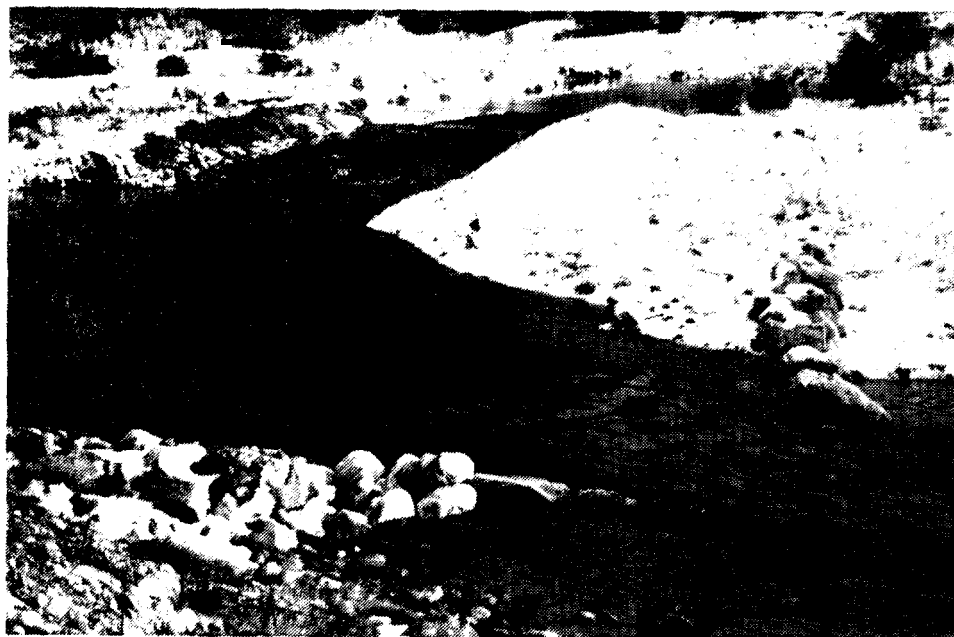
Figure 7 - Pinch weir

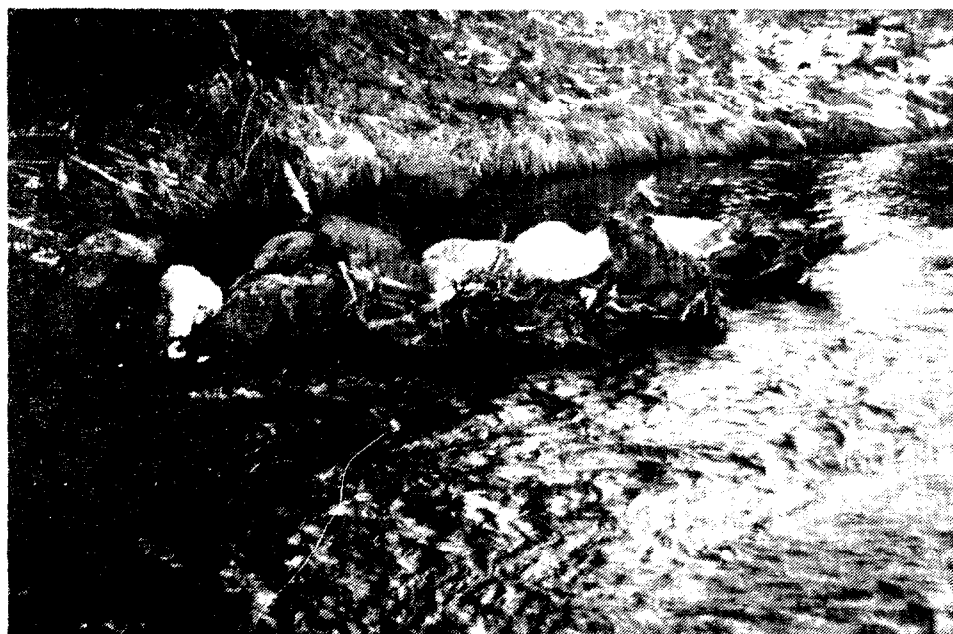
Figure 8 - Root Wad Clusters

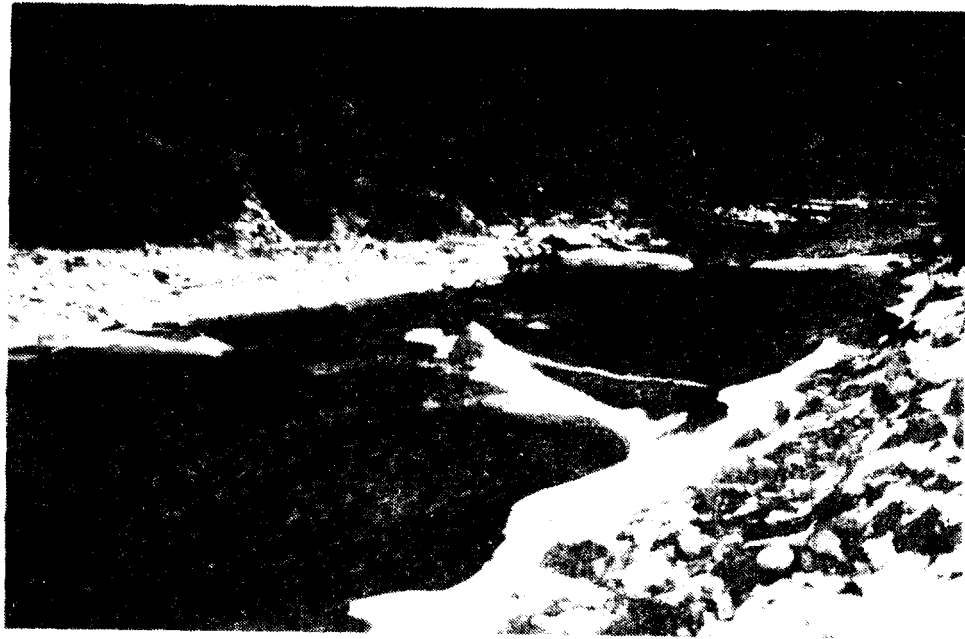
Figure 9 - Deflector Log

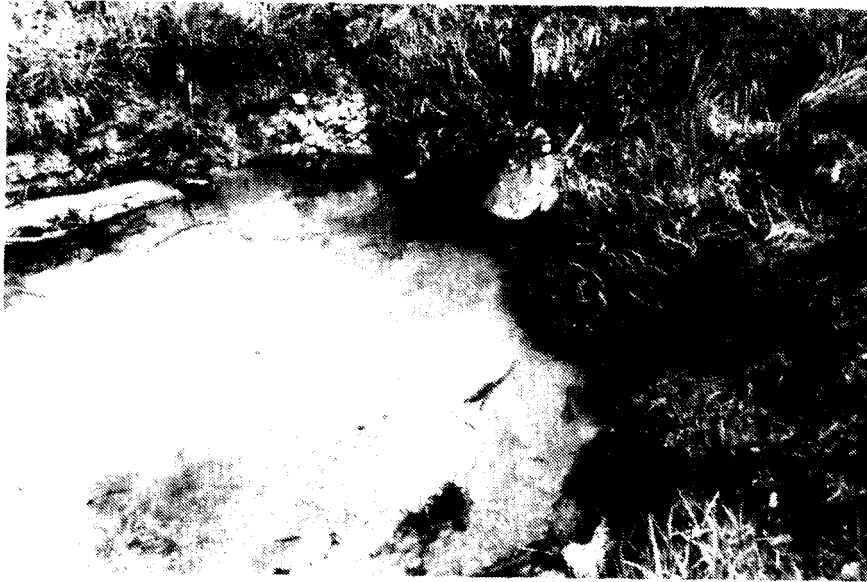
In 1988, a side channel was constructed at the site of the existing off-channel sediment trap in reach II. A culvert functioned as the inlet control structure for the side channel. This culvert was so efficient at taking in sediment that the small sediment basin behind it, as well as the bed of the side channel itself, were buried in sand (see photo 1). After high flow, only a few inches of headspace were left in the **24"** culvert, the rest having filled with sand. About 14 cubic yards of sand were removed from the sediment basin, and the culvert was replaced with a treated-lumber dam-board structure so that the height of the intake and the volume of flow can be manipulated (see photo 2). At times, the new side channel appeared to be backwatering the sediment trap, stopping water from flowing through the trap. The new dam-board structure should not only reduce the amount of sediment flowing into the side channel, but will also permit regulation of the water level in the channel. Seven rock wiers and two boulder clusters were installed in the side channel this year to provide additional habitat diversity for juvenile rearing.

Photo 1. North Fork Red River side channel inlet showing culvert (below rock) and sediment basin with sand accumulation. June 1989

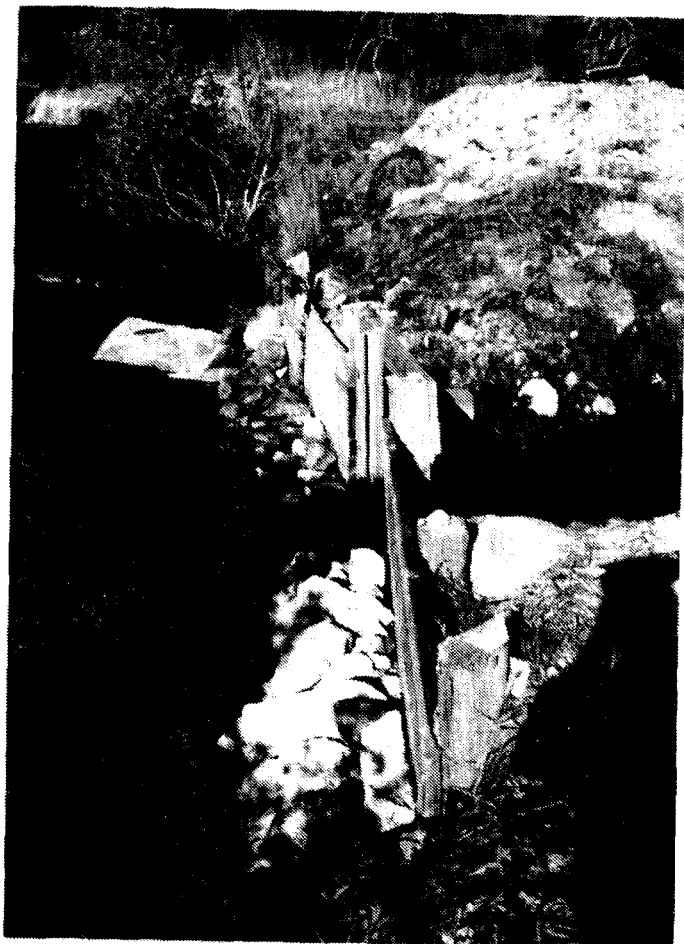
Photo 2.

North Fork Red River side channel inlet after construction of dam-board inlet control structure. September 1989
